Situation, causes and solutions for coastal protection and restoration of coastal mangroves in the Mekong Delta

Abstract: The system of mangrove belt and seadike in the Mekong Delta plays an important role in protecting the behind land againsts natural disasters from the ocean, increasing sediment deposition along the coast, as well as protecting environment, biodiversity, and biological systems. Unfortunately, the mangrove forest in the Mekong Delta has been seriously degrading in recent decades, even completely disappeared at several areas. Coastal erosion has damaged houses, infrastructures (i.e seadike, road,...), properties of people living in the coastal area. By analysing historical data, remote sensing data in several years and also by using numerical and physical models, the change of coastline and the main causes of coastal erosion were carried out, from which the feasible solutions for coastal erosion protection and mangrove forest restoration for the Mekong delta coast were proposed.

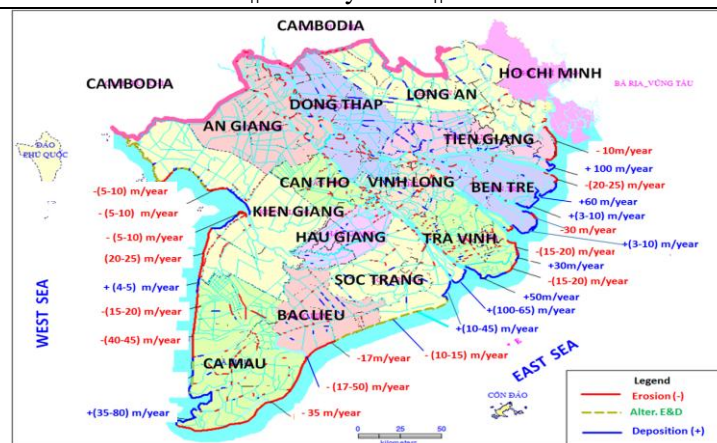
Figure 7. Coastal erosion and mangrove degradation in the Mekong Delta

The overview of coastal erosion and mangrove degradation in the Mekong Delta is synthesized and shown in Figure 7. This result is established by numerical models, analysing remote sensing images, GIS satellite images, analyzing historical documents from different sources [3,4], then verifying reality.

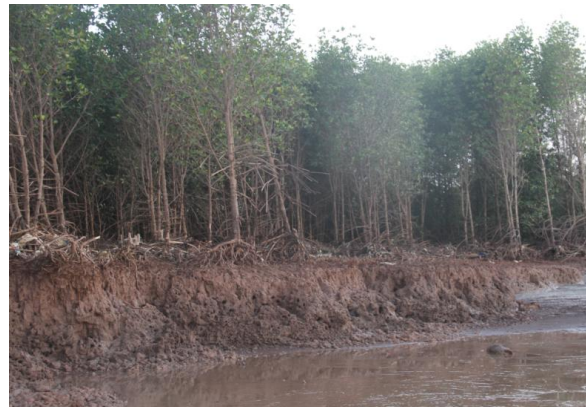
Figure 8. Coastal erosion and mangrove degradation in Go Cong, Tien Giang province

Some areas of rapid erosion such as Go Cong Dong (Tien Giang province), Vinh Chau (Soc Trang province), Ganh Hao (Bac Lieu province), Ca Mau (Ca Mau province) show that the smaller the width of the protective forest belt is, the faster the erosion occurs.

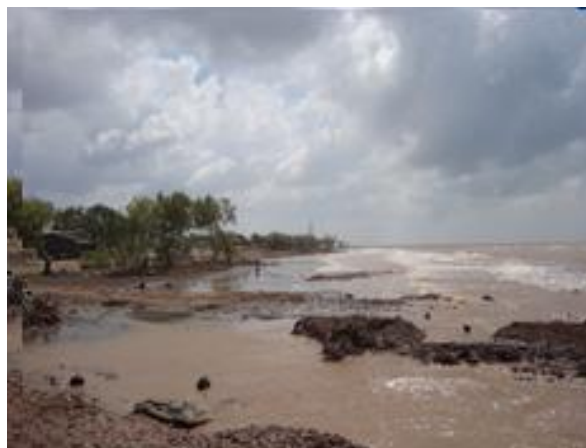
Figure 9. Coastal erosion and mangrove degradation in Vinh Chau, Soc Trang province

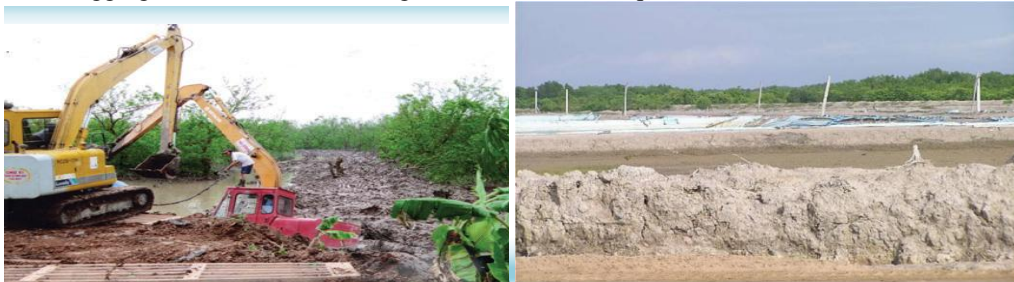
Deforestation, digging canals for flood drainage, alum alkalis and aquaculture.

Figure 12. Digging of canals and ponds ... broke the natural stability of the coastal lowlands

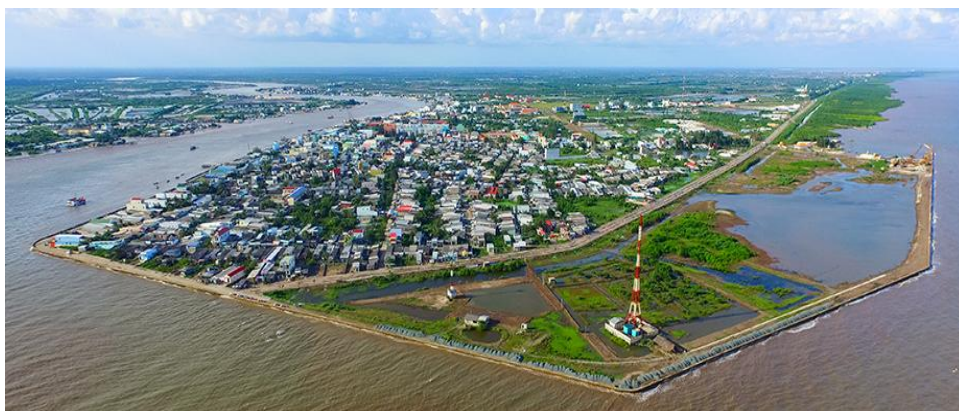
Figure 14. Ganh Hao beach and estuarine encroachment has changed the morphology and caused severe erosion for many years. [7]

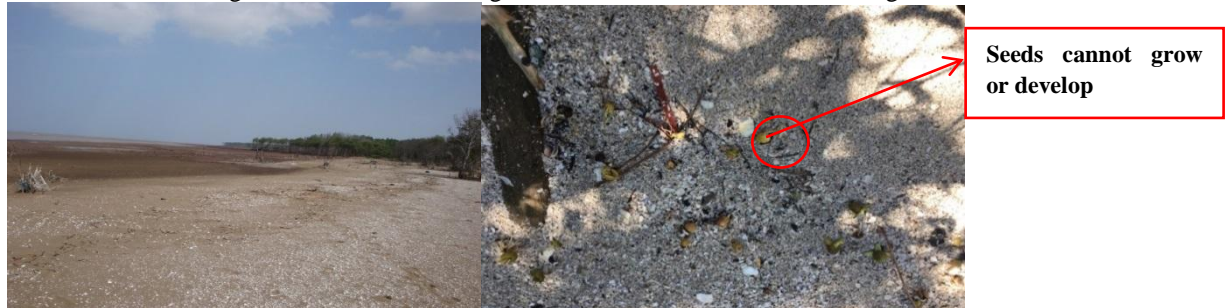
Figure 15. The beach lacks alluvium and nutrition and is always affected by waves and currents, so trees cannot grow. (Photo taken 6/2017)

+ Groups of human activities change the dynamics, sediment deficiency, and nutrition. The results show that hydropower reservoirs on the Mekong mainstream retained a significant amount of sediment, reducing the amount of silt to the sea by more than 40% [5,6]. Construction of sea dykes prevents the overflows of nutrition from the beach, mangrove forests and non-regenerable forest belts, as shown in Figure 15.

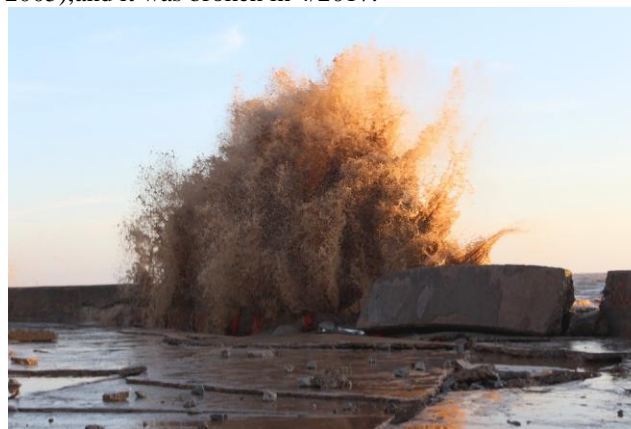
Figure 16. The protection of Ganh Hao town in Bac Lieu province broken by waves in 4/2017 (source: tuoitre.vn)

The group of causes consists of a number of factors, but can be divided into two categories: active elements and passive elements. Active elements break the morphology of natural stability and gradually expand erosion in space and time such as wind, tide ..., while passive elements belong to the group of integers. The objective factor, which is the property of the coastal zone such as: shoreline material, shoreline morphology, coastal terrain, vegetation cover, has a great impact on the scale and speed of erosion. Climate change and sea level rise have deepened the situation of coastal erosion and mangrove forest degradation in the Mekong Delta, due to the more intensified, more powerful, and deeper coastal areas as well as stronger pressure. Below is a photo of the coastal protection work in the populated area of Ganh Hao town, Bac Lieu province. Sheet piles is built over 10 years (built in 2005), and it was broken in 4/2017.

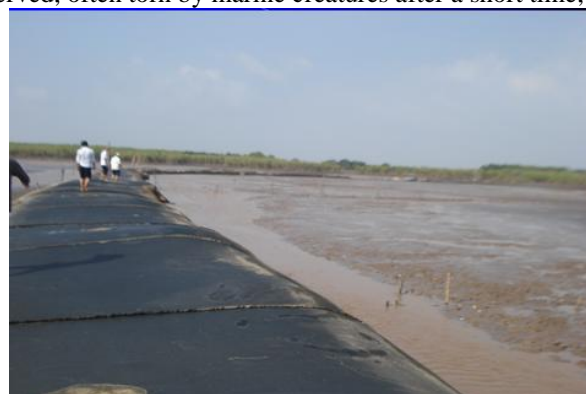
Figure 18. Wave collection by Geotube at Nha Mat in Bac Lieu province has no effect on wave deceleration due to the crest has been lower than the 1.2 m design.

-Application of Geotube to build longshore reef breakwaters does not bring about the desired effect, because the peak is not preserved, often torn by marine creatures after a short time;

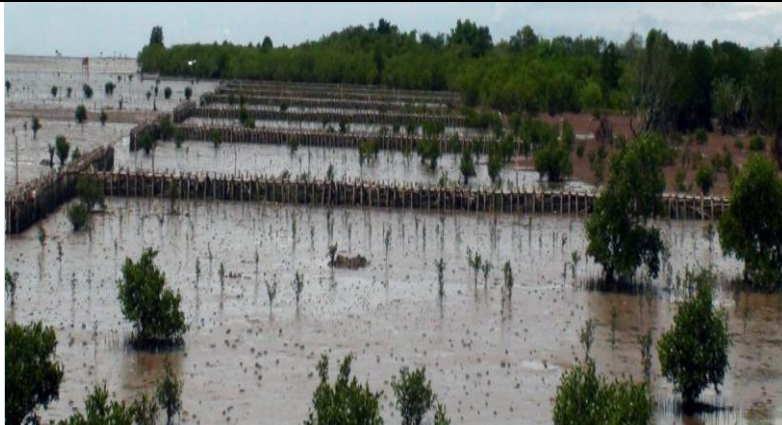
Figure 19. The fence for beach feeding and rehabilitating mangrove forests in the GIZ project in Bac Lieu,

-Beach replenishment by bamboo and melaleuca forest fences, step by step rehabilitating the mangroves at bend scour in shallow sea then moving to deeper positions. Experience from the GIZ project shows that mangroves are rapidly and sustainably rehabilitated. Below is a fence to facilitate the process of accretion in the Bac Lieu coastal area, with the re-depositing speed within the fence of about 10 cm per year [13].

This study recommends that a T-fence for accretion and rehabilitation of mangroves at shoreline sites which have been heavily encroached on the shore be built. In further studies, detailed wave parameters, coastal currents, sediment load at each location to arrange fences with suitable height, direction will be carefully examined.

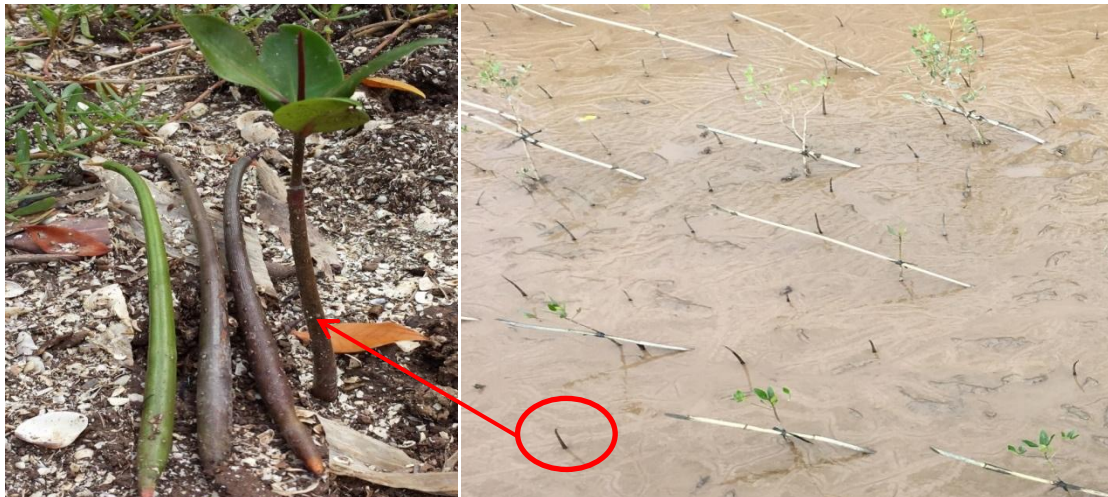
Figure 20. Rhizophora regeneration when sediment layer is over 10 cm at Soc Trang beach (photo taken 6/2017).

When silt reaches a height of more than 10 cm, the plants will grow on their own and are very stable in the long run regardless of the effects of natural conditions, waves and winds. Survival rate after one year is over 90%, while the survival rate of trees which are brought from nursery gardens to be planted in this area is only 10%.
